Seismic performance of historical buildings based on Discrete Element Method: An adobe church

Nuno Mendes^a, Sara Zanotti^b, and José V. Lemos^c

This paper presents the main concepts and the application of the Discrete Element Method for evaluating the seismic performance of historical buildings. Furthermore, the out-of-plane behavior of an adobe church with thick walls, in which the morphology of the cross-section can have an influence on the response, was evaluated by the Discrete Element Method. The performance of rigid and deformable blocks models was compared, and the sensitivity of the numerical model to the variation of critical parameters was investigated. The results allowed the identification of the most vulnerable elements and a proposal of recommendations for reducing the seismic vulnerability.

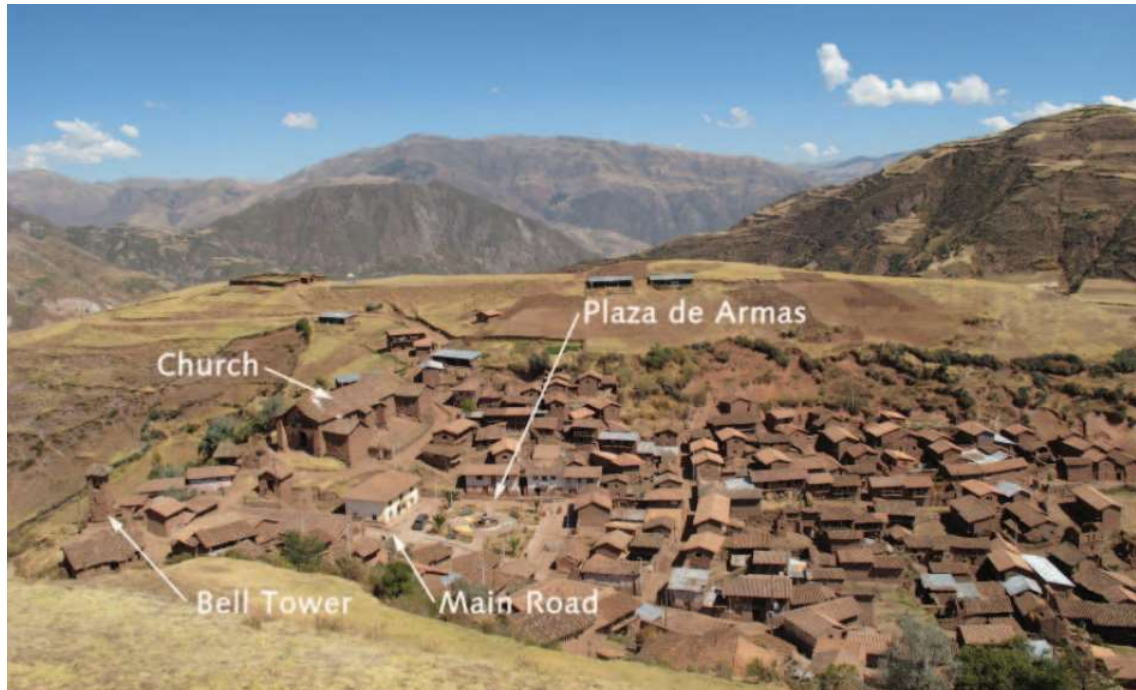
FIGURE 1 Aerial view of Kuño Tambo village (Peru) and location of the church [Cancino et al., 2012].

The Kuño Tambo church is a one-story building composed by the nave, presbytery with altar, baptistery, sacristy and choir loft (FIGURE 2a). Furthermore, it has a bell tower not structurally connected to the building (FIGURE 1). The walls were built with adobe bricks on a base course (FIGURE 2b). The roof was constructed with timber elements, based on the *par y nudillo* method. The *par y nudillo* is a traditional method that consists of two rafters with a diameter of 0.20 m, joined through a collar tie (FIGURE 2c). The church was constructed on a natural rock outcrop. Compacted clay fill layers were used

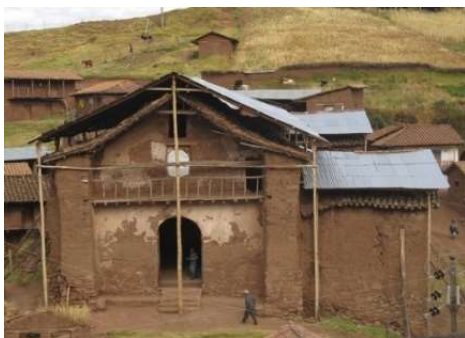
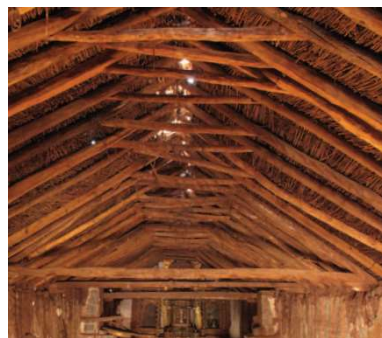
FIGURE 2 Kuño Tambo church: (a) Plan and longitudinal section; (b) Main façade; (c) Roof of the nave [Cancino et al., 2012]. (Dimensions in meters)

to level the site. Thus, the foundation sits directly on the natural rock or the compacted clay fill. Currently, the church has two buttresses at the east wall of the nave. Two buttresses that existed at the west wall of the nave have collapsed. In addition, the church has buttresses at the corners that correspond to extensions of the walls (FIGURE 2a).

The thickness of the lateral walls of the main nave varies between 1.60 m and 1.90 m, with a maximum height of 6.60 m (measured from the visible top of the rubble stone masonry base course). The main façade, located south, and the north wall have a thickness of 1.90 m and 1.30 m, respectively. The height of the façade at the gable end is 8.70 m. In general, the walls are well connected to each other by the overlapping of mud bricks, with the exception of the baptistery, which was constructed adjacent to the eastern wall of the main nave (FIGURE 2a). However, the southern and the northern walls are not well connected to the lateral main nave walls. Regarding the buttresses placed along the east wall of the nave, all are connected to the nave walls with overlapping bricks.

lateral wall, the buttresses were strengthened by adding new adjacent buttresses without structural connection to the existing walls. Currently, only one of the strengthening buttresses remains (FIGURE 2a).
